Remote surface damage detection on rotor blades of operating wind turbines by means of infrared thermography

Dominik Traphan¹, Iván Herráez², Peter Meinschmidt³, Friedrich Schlüter³, Joachim Peinke¹, and Gerd Gülker¹

Abstract. Wind turbines are constantly exposed to wind gusts, dirt particles and precipitation. Depending on the site, surface defects on rotor blades emerge from the first day of operation on. While erosion increases quickly with time, even small surface defects can affect the performance of the wind turbine. Consequently, there is demand for an easily applicable remote monitoring method for rotor blades that is capable of detecting surface defects at an early stage. In this work it is investigated if infrared thermography (IRT) can meet these requirements by visualizing differences in the thermal transport and the corresponding surface temperature of the wall-bounded flow.

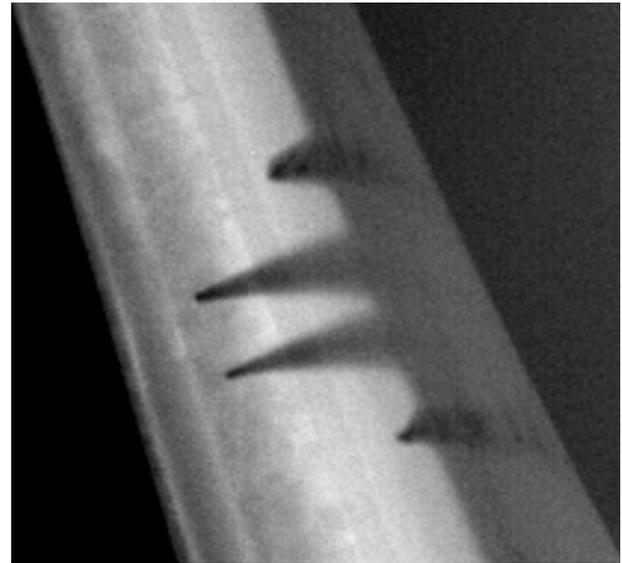
Figure 1. Thermogram of a rotor blade's suction side of an operating wind turbine: natural laminar–turbulent boundary layer (BL) transition and turbulent wedges generated by surface roughness elements appear darker. The view is from behind the turbine; i.e., movement is leftwards. The thermogram was taken with a 200 mm telephoto lens in the morning sun; i.e., surface is about 2 °C colder than the air.

A thermogram of a moving rotor blade after just a couple of months of operation is depicted in Fig. 1 (color coded in gray scales, the darker the colder). The thermal pattern includes footprints of turbulent wedges generated by surface roughness, mostly originating close to the leading edge and merging into the natural laminar–turbulent transition (hereafter referred to as the transition). In this case, turbulent regions appear colder since the rotor blade is warmed up by the morning sun while the air is still cold from the night.

Certainly not every turbulent wedge corresponds to a severe defect, but Fig. 1 draws a vivid picture of the condition of new rotor blades. Typical surface faults at a young age of a rotor blade are residue from manufacturing, damages from transportation and first erosion pits. Since surface defects are in general to be avoided for economic and safety reasons, this study aims at proving the concept of IRT as a remotely operating inspection method that is capable of providing information about the type of surface defect just from the flow formation mapped by the thermogram. This implies, for the first time, the following objectives:

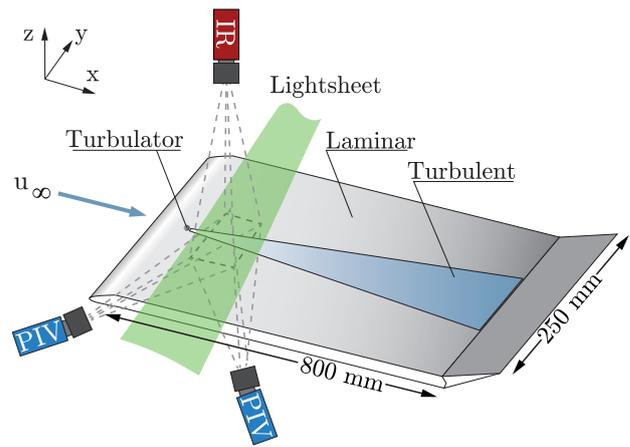
Figure 2. Experimental setup for SPIV and IRT measurements of a turbulent wedge emerging on a flat plate downstream of a turbulator.

695 velocity fields per second at a full resolution of $1920 \times 1200 \text{ px}^2$. The light sheet is adjusted parallel to the surface at a distance, $z = \delta_{u/2} < 1 \text{ mm}$, where 50 % of the free-stream velocity, u_∞ , is present in the laminar BL. Due to moderate growth of the BL, this height remains approximately constant over the region of interest. In this way, a sufficient accuracy (stereo residue $< 0.5 \text{ px}$) and difference in velocity between the laminar BL and the wake of the turbulator is obtained.

Thermal measurements are carried out using an IR-CAM Equus 327kM infrared camera featuring a resolution of $640 \times 512 \text{ px}^2$. Since presented results are steady-state only, an integration time of 2 ms along with a thermal resolution of $\Delta T = 15 \text{ mK}$ yields low-noise and detailed thermograms. Using a temperature difference δT between surface and flow that enables mapping flow features onto the surface is referred to as the “method of temperature steps” (Tropea et al., 2007). Accordingly, this experimental setup exploits a δT emerging from the wind tunnel warmed up by its fan and the cooler laboratory without any additional heating or cooling applied on the flat plate. Thermal contrast of turbulent regions remains recognizable as long as the heat capacity of the PVC plate and its internal equalization by thermal conduction are sufficient. The low thermal conductivity of PVC thus enables detailed mapping of flow features.

The infrared camera is adjusted perpendicular to the flat plate. Both measurement techniques, SPIV and IRT, cover congruent fields of view extending approximately $\Delta x \times \Delta y = 20 \times 70 \text{ mm}^2$ in the wake of the turbulator (x and y are denoted according to Fig. 2). A hemispherical turbulator with a diameter of $d = 3.5 \text{ mm}$ serves as a generic defect located at a distance of $\Delta x = 100 \text{ mm}$ from the leading edge of the flat plate. The black PVC plate (size: $800 \times 250 \text{ mm}^2$) is provided with a high-precision hyperelliptic leading edge keeping the BL attached and laminar (Narasimha and Prasad, 1994). Obviously, the induced transition is strongly depen-

dent on the Reynolds number and free-stream properties. Minimizing the impact of the latter, the experiments are performed in a wind tunnel (inlet: $250 \times 250 \text{ mm}^2$, length: 2000 mm, closed test section equipped with IRT window) featuring a low turbulence intensity of $Ti < 0.4\%$. An increasing Reynolds number with respect to the height of the turbulator – $Re_h = u_\infty d / \nu$, where u_∞ denotes the free-stream velocity and ν the kinematic viscosity – corresponds to a stronger destabilization of the BL and represents a more relevant surface defect. The impact of the turbulator is thus varied by changing $u_\infty \in [7; 17] \text{ m s}^{-1}$, i.e., $Re_h \in [700; 1750]$.

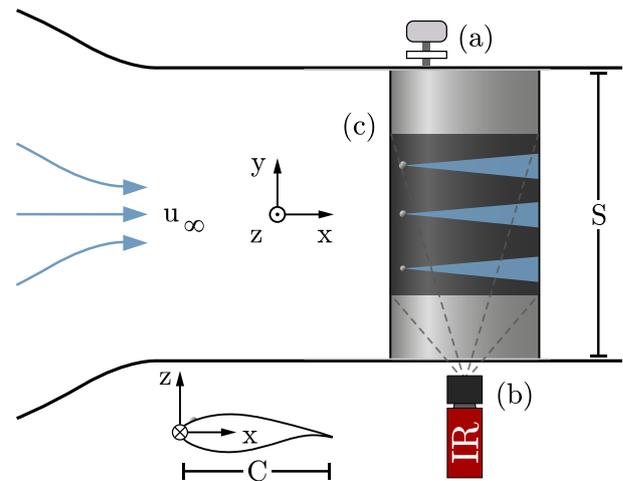
Figure 3. Experimental setup for lift (a) and IRT measurements (b) of a DU 91-W2-250 airfoil (c) modified with turbulators.

The experimental setup shown in Fig. 3 allows us to compare aerodynamic forces with IRT measurements. In this way, the aerodynamic impact of turbulent wedges is investigated on a DU 91-W2-250 airfoil. The airfoil has dimensions of $S \times C = 805 \times 300 \text{ mm}^2$ where S denotes the span and C the chord length of the airfoil. It is mounted at the quarter chord point on an axis which is precisely turned by a stepper motor for setting the angle of attack (AoA). For accurate aerodynamic measurements, the high-precision airfoil is made of aluminum. In general, aluminum is not considered to be suitable for IRT applications because of high thermal conductivity blurring any thermal contrast by internal heat equalization (Tropea et al., 2007). To overcome this problem, the airfoil is covered with a matte black PVC foil (thickness $< 100 \mu\text{m}$) which inhibits the thermal conduction transversally to the surface while the geometry is negligibly changed (Reyer et al., 2006; Joseph et al., 2016). Such a configuration provides sharp thermal imaging with sufficient heat capacity to maintain temperature differences that emerge due to flow characteristics. Additionally, reflections in the infrared spectral range are minimized along with a maximized emissivity being crucial for reliable IRT.

the infrared camera is adjusted perpendicular to the plane defined by the chord length of the airfoil and its span at zero AoA. The method of temperature steps is again applied using temperature differences between the up to 2°C cooled wind tunnel flow and the ambient air. The temperature difference is achieved by cooling the wind tunnel to about 2°C below the ambient temperature of the air in the laboratory.

As defects on rotor blades usually occur on the suction side in distances x from the leading edge of $x/C < 0.13$ (Sareen et al., 2014), three hemispherical turbulators (see Fig. 3) of different diameters $d = 1, 2, 3 \text{ mm}$ are placed on the suction side at the chordwise position $x/C \approx 0.1$. In terms of the turbulator Reynolds number, Re_h , the different sizes of the turbulators along with a variation in inflow velocity simulate both growing surface defects as well as spanwise position on a rotor blade (from root to tip).

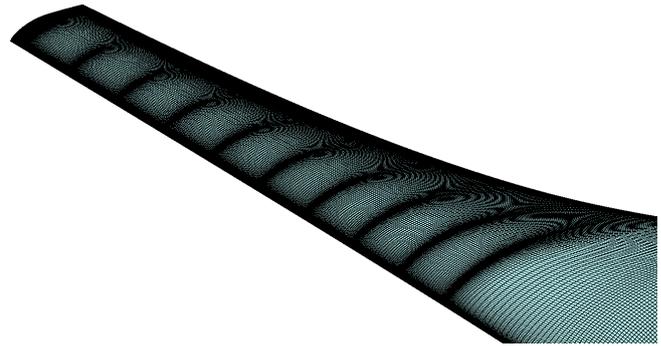
Figure 4. Surface mesh of the blade including 10 generic surface defects uniformly distributed in the range $0.5R \leq r \leq 0.99R$. The regions in the vicinity of turbulators present an increased cell density.

The computational mesh, which is created with the software Pointwise (Pointwise Inc, 2015), is of the block-structured type; see Figs. 4 and 5. The domain is semi-spherical and the outer radius has a length $22R$, where R corresponds to the blade radius. The complete mesh contains

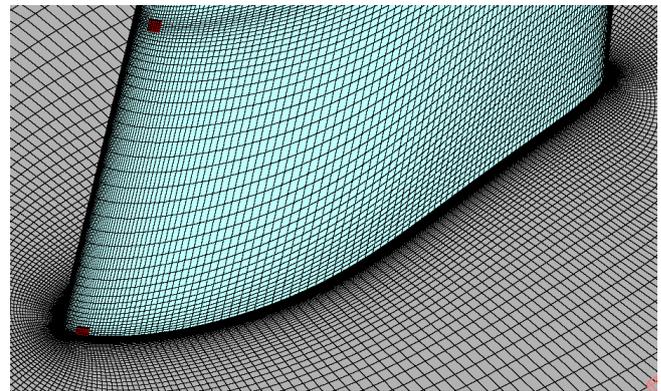
Figure 5. Surface mesh of the blade and volume mesh around it. Two generic surface defects are highlighted in red color.

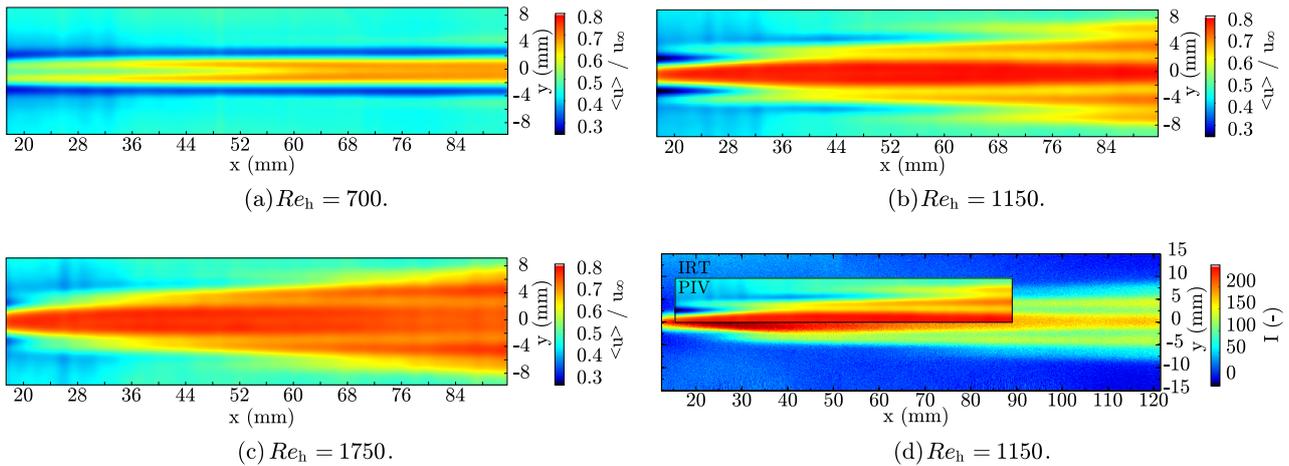
Figure 6. Averaged SPIV measurement of a turbulent wedge on a flat plate downstream of a generic surface defect at different Reynolds numbers in (a)–(c). Overlaying the thermogram with SPIV results in (d), which allows direct comparison with each other. Color coding of the thermogram represents digital values, I , spanning roughly 2°C . Limits are chosen to match the dynamic range of the SPIV measurement. Defect d at $(x, y) = (0, 0)$; velocity magnitude u normalized by free-stream velocity u_∞ ; light sheet parallel to surface.

Increasing the Reynolds number towards $Re_h = 1150$ reveals a characteristic change in the shape of wedges (see Fig. 6b). Perturbations arising from the turbulator start to spread symmetrically around $y = 0$ mm. The BL becomes more perceptive for perturbations forming a ragged contoured wedge in the mean velocity field. The two trailed vortices from the turbulator induce another counter-rotating vortex pair downstream of $x \approx 52$ mm. This cascade continues while propagating downstream. When the Reynolds number is increased towards $Re_h = 1750$ (see Fig. 6c), perturbations continuously spread and form a smoothly shaped turbulent wedge in the mean velocity field.

A thermogram for $Re_h = Re_h^{\text{crit}}$ consisting of two laterally shifted and stitched thermograms is presented in the background of Fig. 6d. It is overlaid by an extract of the corresponding velocity field obtained by SPIV whose color coding is the same as in Fig. 6b. The thermogram is color coded in raw digital values to match the color range of the velocity field allowing easier comparison. The dynamic range of the thermogram is roughly 2°C .

Both measurement results show good qualitative agreement. Each flow feature in the velocity map has a visual counterpart in the thermogram. This finding holds true for the other Reynolds numbers, Re_h^{sub} and Re_h^{sup} (not shown here). As a conclusion for a flat plate, IRT is capable of appropriately representing (quasi-)stationary flow features in the BL with moderate experimental effort. In the wake of a turbulator, flow features depend on details of their generation providing evidence for the significance of a turbulator and surface defect by means of the thermogram only. In order to check whether surface material or curvature affects the so-far uncovered relations, turbulent wedges emerging on an aluminum airfoil are studied in the following Sect. 3.2. Besides, the aerodynamic impact of turbulators applied to this airfoil is assessed.

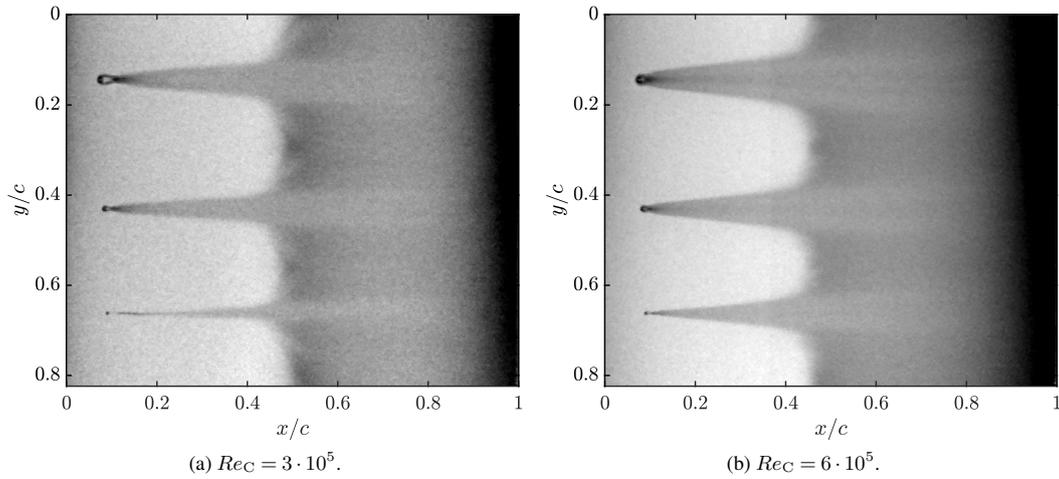
Figure 7. Thermogram of turbulent wedges generated by three hemispherical turbulators of diameter $d = 1, 2, 3$ mm (from bottom to top) on a DU 91-W2-250 profile ($\alpha = 12^\circ$) located at $x/C = 0.09$ and displaced by $\Delta y/C = 0.5$ for two different Reynolds numbers. Depiction in gray scales and color coded in digital values ($\Delta T < 2^\circ\text{C}$).

The magnitude of the wall shear stress on the suction side of one total rotor blade is shown in Fig. 11. The figure is depicted in gray scales with arbitrary units for easier comparison with Fig. 7. As it can be seen, the turbulent wedges are clearly visible for all radial positions. This is also true for the outermost location in spite of the strong influence of the tip vortex, which makes the turbulent wedge to be deflected towards the inner part of the blade. In general, these turbulent wedges highly resemble the ones obtained from the thermal footprints of the flat plate (cf. Fig. 2) and the airfoil (cf. Fig. 7).

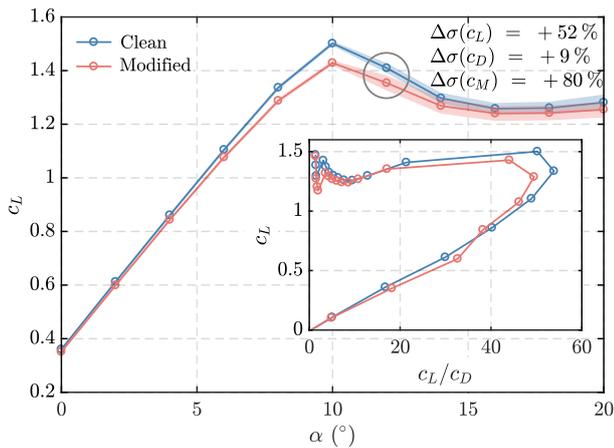
Figure 8. Lift coefficient c_L over angle of attack (AoA) of a clean DU 91-W2-250 profile (\circ) and a modified one with generic surface defects (\oplus). The insert shows measured lift coefficients and corresponding lift–drag ratios. The respective $\Delta\sigma$ specifies the increase in fluctuations of the associated quantity in terms of standard deviation.

The modified airfoil performs consistently worse than the clean one. The deficit in lift increases towards the AoA of maximum lift, $\alpha_{\max} = 10^\circ$, and decreases beyond. Since lift correlates to some degree with energy output, a lift deficit of up to 5% at α_{\max} is generally unfavorable for a wind turbine. Inferior performance of the modified airfoil is also reflected by a lift-to-drag ratio, c_L/c_D , which is almost 10% lower, as seen in the insert of Fig. 8. In order to examine the lift stability that strongly affects a wind turbine in terms of fatigue, we take a closer look at the maximum lift range. This reveals a striking difference between the two conditions. In the post-stall range, particularly at $\alpha = 12^\circ$, the modified airfoil exhibits fluctuations of lift and pitching moment increased by more than $\Delta\sigma(c_L) \approx 50\%$ and $\Delta\sigma(c_M) \approx 80\%$, respectively. Under real inflow conditions inducing off-design AoA, the presence of protruding surface defects on airfoils potentially induces more flow instabilities and, in turn, larger dynamic loads leading to premature material fatigue.

In Fig. 8, the performance of the DU 91-W2-250 airfoil is shown to be significantly reduced at AoA close to the stall onset when turbulators are applied to the suction side. However, in the wind turbine simulation no significant change in the aerodynamic performance is detected with respect to the baseline case. Several reasons exist for this behavior: on the one hand, the angle of attack for $r/R \geq 0.5$ is $\alpha \approx 7^\circ$ at all radial positions where the turbulators are located. This is a few degrees below the stall angle, so the influence of the turbulators is correspondingly expected to play a minor role (cf. Fig. 8). Furthermore, previous experiments have shown that the DU 96-W-180 airfoil (used in the simulated blade) presents low sensitivity to leading edge roughness (Timmer

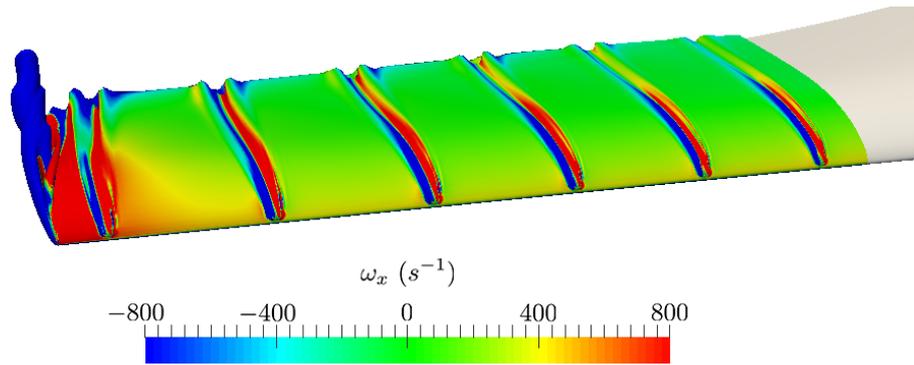
Figure 9. Iso-surface of the vorticity in the chordwise direction past six turbulent wedges on the suction side of a rotating blade.

Figure 9 displays iso-surfaces of the vorticity in the chordwise direction, ω_x , for the six outer-most turbulators. It is observed that the flow downstream of the turbulators is characterized by well defined vortical structures. From the figure, it is also clear that the wake of each turbulator is characterized by two counter-rotating vortices: the vortex just outboard of the turbulator rotates in the same direction as the tip vortex (also depicted in the figure), whereas the vortex just inboard of the turbulator rotates in the opposite direction. These vortices give rise to the characteristic turbulent wedge in the BL described in Sect. 3.1 and 2.2.

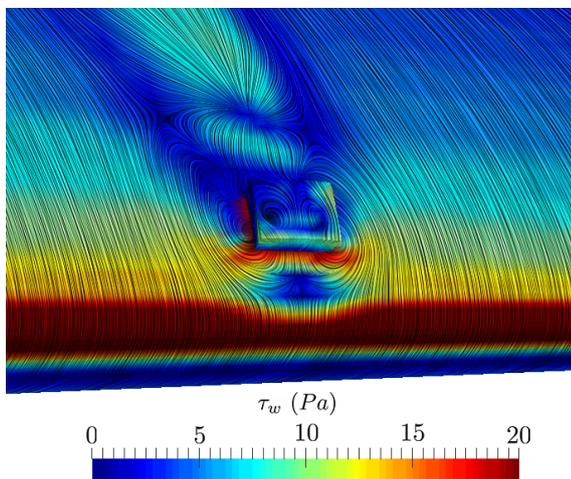
Figure 10. Detail of the limiting streamlines over a turbulator located at $r/R = 0.66$ as observed from the leading edge. The magnitude of the wall shear stress, τ_w , is depicted over the blade surface. The footprint of the flow around the turbulator, which is located in the center of the figure, is characterized by a set of vortical structures winding around it.

Figure 10 provides further insight into the emergence of the turbulent wedges. In the figure, the flow around a single turbulator is observed from the leading edge by means of limiting streamlines representing the wall-bounded flow. In order to illustrate the thermal footprint of the flow, the so-called Reynolds analogy is applied (Kakac and Yener, 1994). According to that, the magnitude of the wall shear stress, τ_w , around a generic defect images the thermal map that an infrared camera would capture. The footprint of vortical structures winding around the turbulator is clearly visible. The resulting horseshoe vortices impinge onto the blade surface behind the turbulator and then propagate downstream, as also seen in Fig. 9. These results verify the interpretations

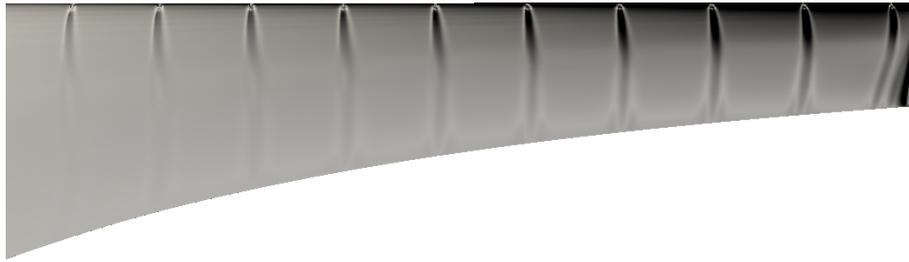
Figure 11. Distribution of wall shear stress obtained from the RANS simulation of a rotor blade with 10 turbulators equally distributed along the span in the range $0.5R \leq r \leq 0.99R$ and localized at the same relative chordwise position $x/C = 0.01$. This figure resembles the representation resulting from a thermogram (Reynolds analogy; see Kakac and Yener, 1994). Gray scales in arbitrary units for facilitating the comparison with Fig. 7.

However, the wakes of the turbulators in the inner region seem to vanish sooner in the blade than in the airfoil. This might be an artifact of the simulation attributed to the high dissipation of RANS models. For the other blade turbulators, a greater similarity with the IRT results is achieved. It is worth recalling that the turbulator-based Reynolds number Re_h increases linearly from the innermost turbulator ($r/R = 0.5$) to the outermost one ($r/R = 0.99$) owing to the continuous increase in effective local inflow velocity from the root to the tip. From Table 1, it is clear that the four innermost turbulators are in the subcritical range introduced in Sect. 3.1. The fifth and sixth turbulators can be considered to be in the critical range. The four outermost ones belong to the supercritical category.

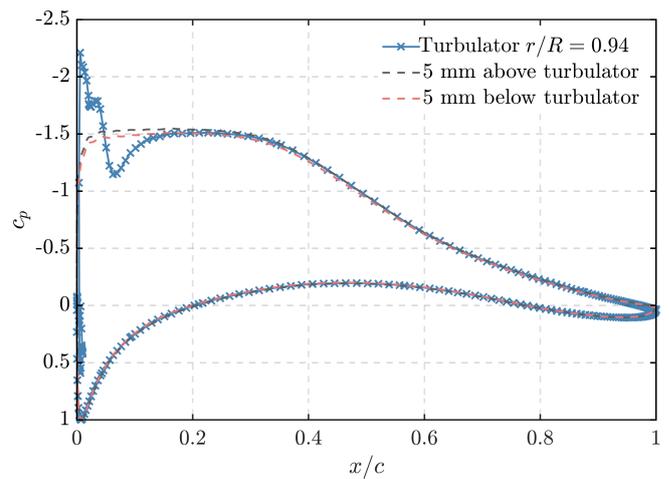
Figure 12. Distribution of the pressure coefficient c_p at the blade section $r/R = 0.94$, corresponding to the location of one of the blade surface defects, as well as c_p distributions 5 mm above and 5 mm below the mentioned location.

Figure 12 displays the distribution of the pressure coefficient, c_p , along the chord for the radial position $r/R = 0.94$, corresponding to the location of one turbulator. Additionally, the figure displays the corresponding c_p distributions 5 mm above and below the surface defect. As it can be seen, the surface defect only has a strong influence on the c_p distribution in the first 20% of the chord length. In that region, the surface defect leads to an increased suction peak and to a sudden pressure rise just after the suction peak, resulting in a local valley. Both effects counteract each other. Correspondingly, the impact of the studied surface defects on the power output is negligible. This indicates that IRT has the potential to detect surface defects long before they are noticeable in the power output signal.
